NAVAL POSTGRADUATE SCHOOL

EFFECTS OF PREHEAT ON WELDMENTS
OF NICOP STEEL

September 1983

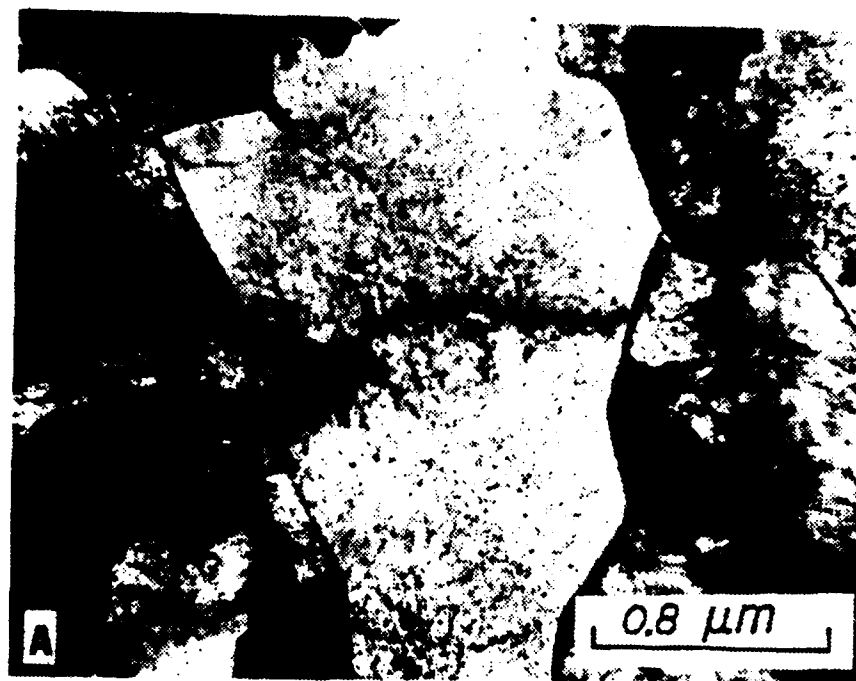
Figure 14. TEM Micrograph of Preheated Weldment Base Material.
 A.) Dislocations and Fine Precipitates in Ferrite Grains.
 B.) Ferrite/Carbide (FC) Aggregates and Ferrite Grains with Dislocations and Fine Precipitates.

Regions believed to contain the net-like structure discussed above appeared to be islands of auto tempered martensite and ferrite/carbide aggregates when observed by TEM (Figures 23 and 24). In some areas a region of martensite and/or ferrite/carbide aggregate exists between the ferrite laths, Figure 25. This morphology appears to be that which was observed in Figure 20. The number of tempered martensite islands and ferrite/carbide aggregates in this region is greater than the number observed at the HAZ/base interface. (Figures 16 and 17) The carbon content of these regions appears to be much higher than the 0.04 percent bulk carbon of the material. In some instances, Figure 23a, this has led to the formation of transformation twins in the martensite. The overall microstructure was lath-like in this region. In both samples there were areas of carbon free ferrite laths with retained austenite at the lath interface, Figure 23. The number density of epsilon copper precipitates observed in the base metal, Figures 14 and 15, was reduced significantly.

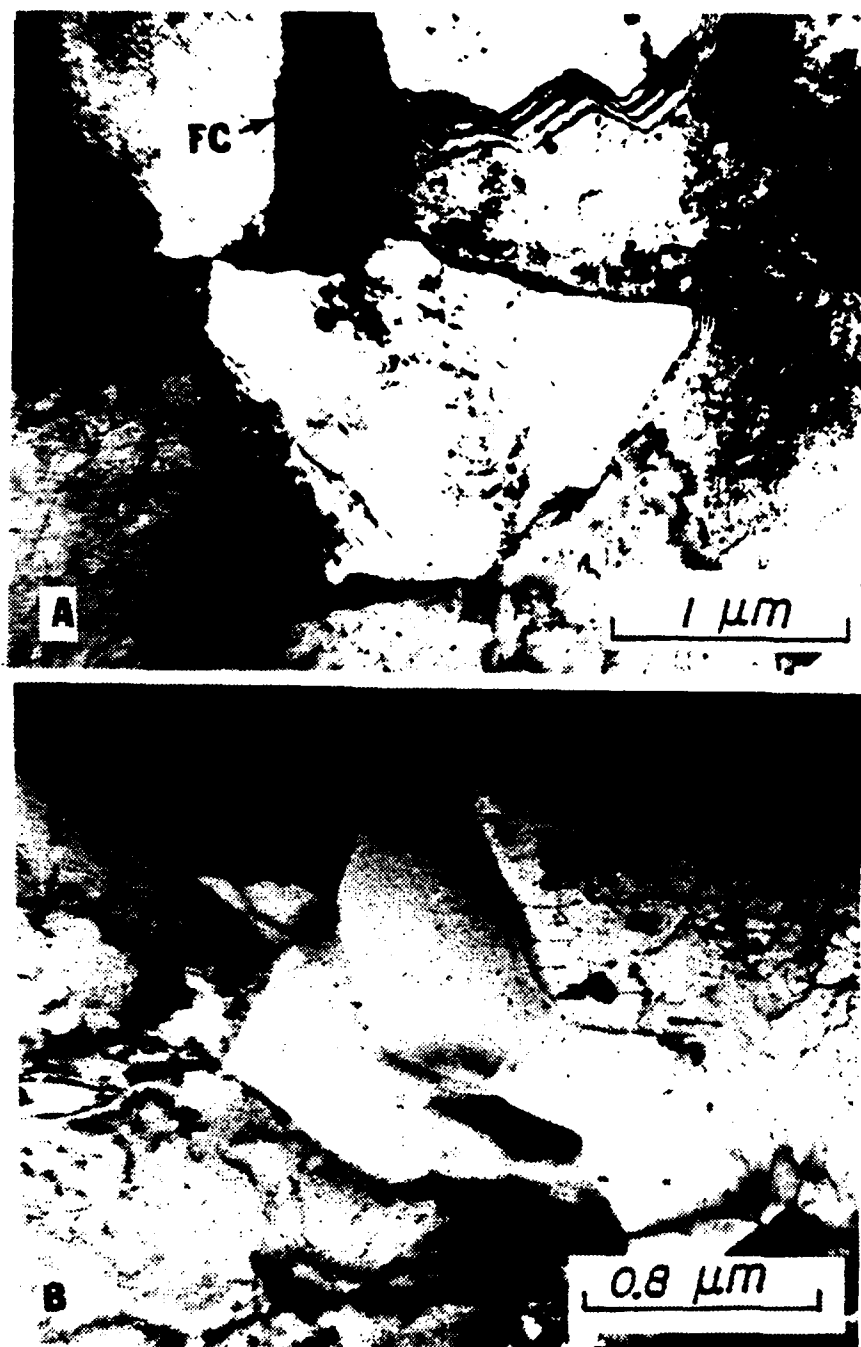
Figure 15. TEM Micrographs of Non-Preheated Weldment Base Material.
 A.) Dispersion of Fine Precipitate in Polygonal Ferrite. Dark Area in Upper Center is Carbide/ Ferrite Aggregate.
 B.) Dislocation and Fine Precipitate in Fine Ferrite Grains.

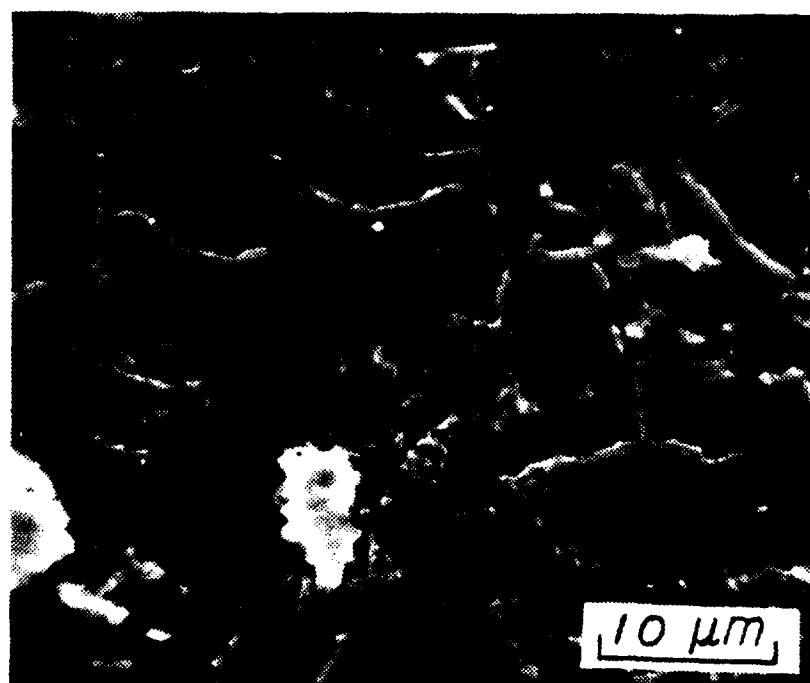
Figure 17. SEM Micrograph of TEM HAZ/Base Region in Non-Preheated Sample. White Appearing Particles are Artifacts due to Sample Contamination.

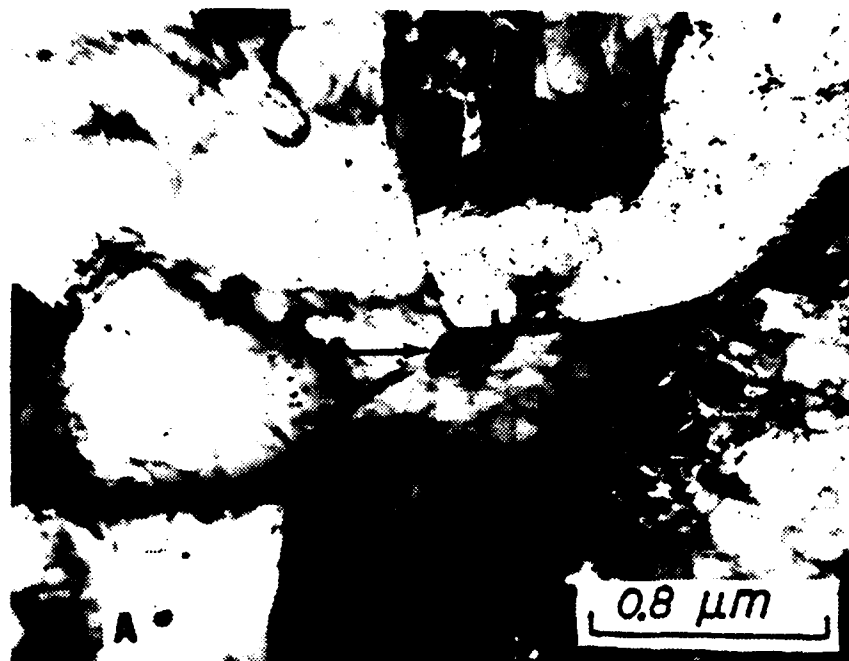
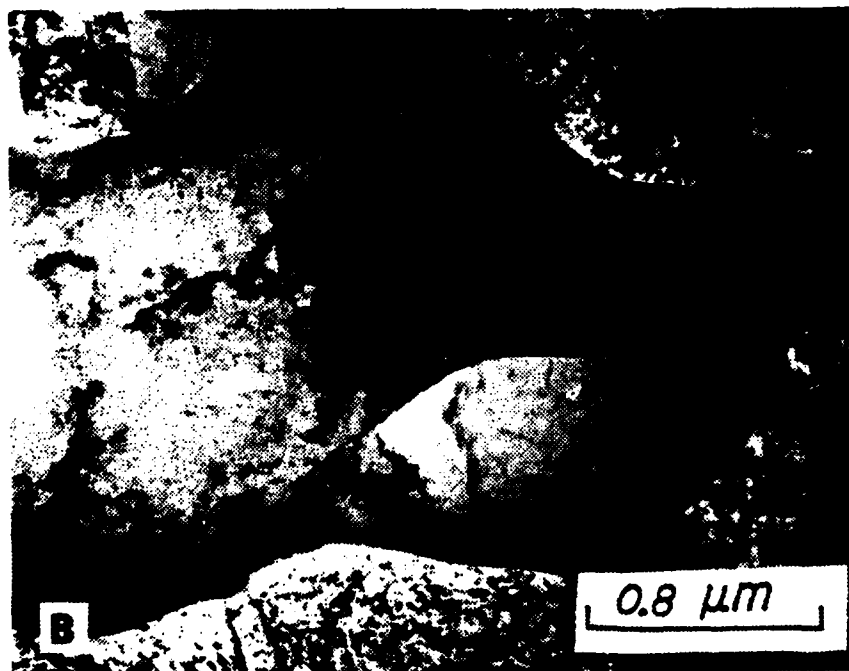
Figure 18. TEM Micrograph of Preheated Sample HAZ/Base Region.
 A.) Fine Precipitate in Dislocated Polygonal Ferrite and Patch of Tempered Martensite at Triple Point Grain Boundary.
 B.) Dislocations and Fine Precipitate Dispersion in Ferrite Grains.

of tempered martensite and carbide/ferrite aggregates in this region as compared to the base metal (Figures 18 and 19). However, these differences are believed to be due to the variation in microstructure of the base metal not due to welding. The dislocation density and epsilon copper distribution was similar to that observed in the parent material.

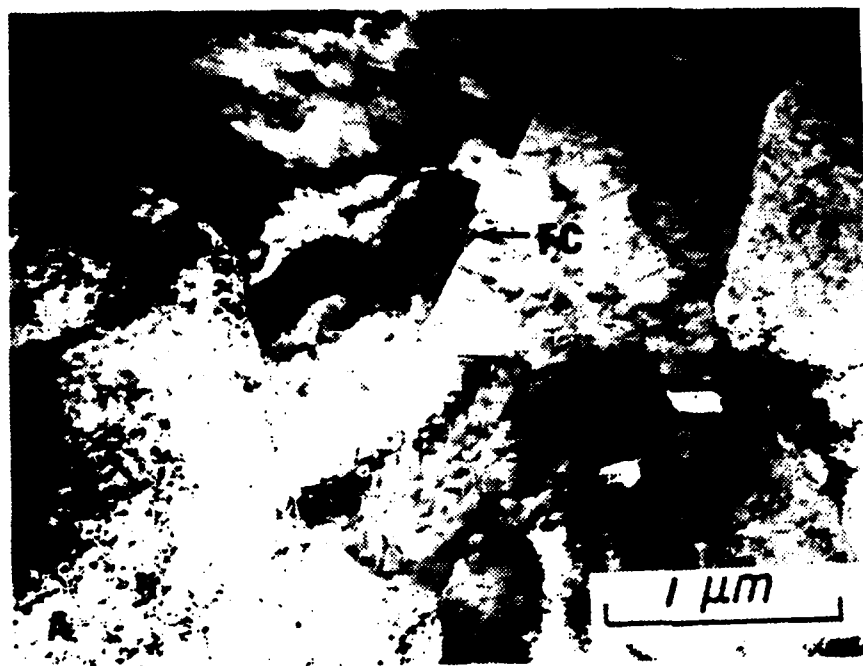
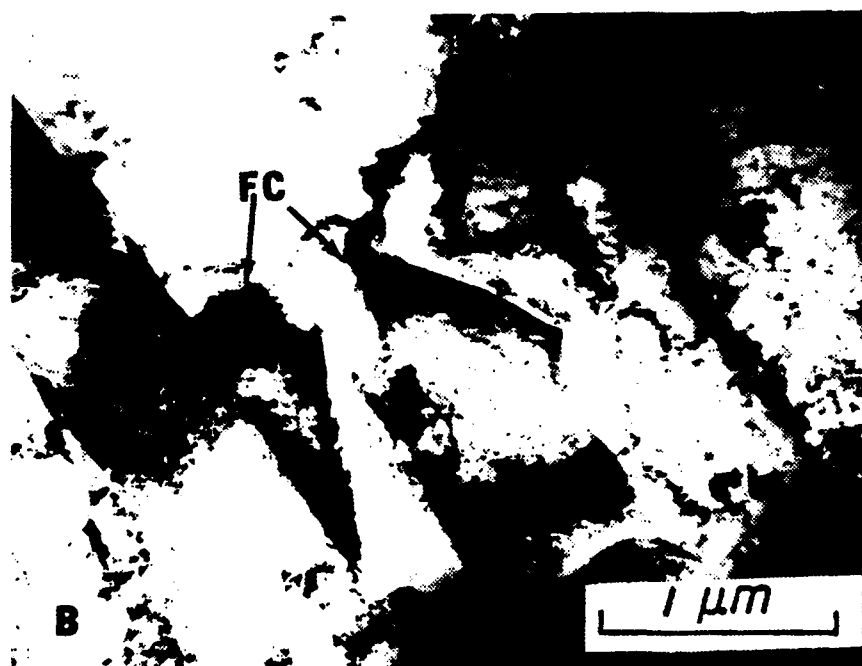
Figure 19. TEM Micrograph of Non-Preheated Weldment HAZ/Base Region.

- A.) Islands of Ferrite/Carbide Aggregates and Dislocations in Ferrite Grains.
- B.) Precipitate and Dislocations in Ferrite Grains. Ferrite/Carbide Aggregates are Indicated.

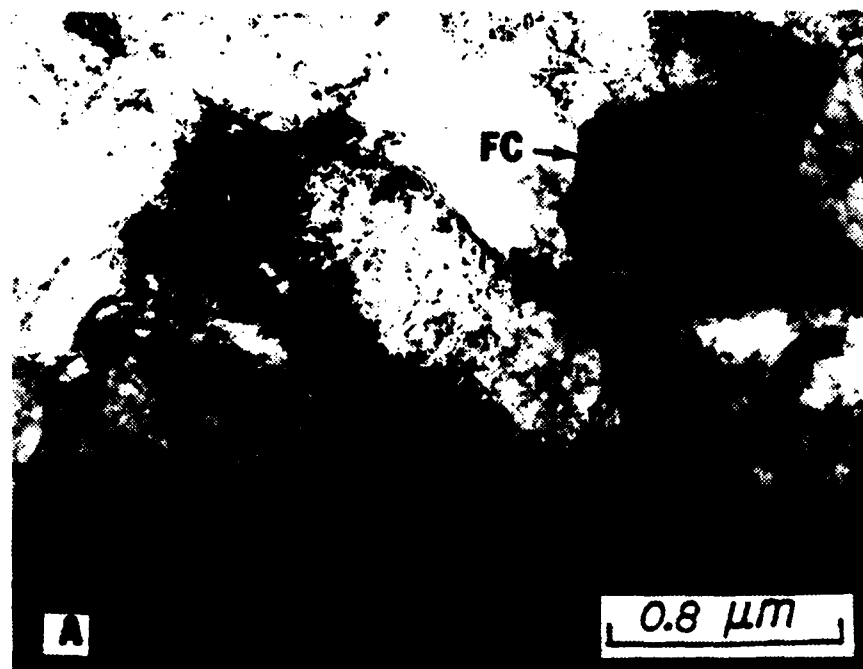
Figure 23. TEM Micrograph of Preheated Sample HAZ Region at Fusion Line.
 A.) Islands of Tempered Martensite and Carbide Aggregates (FC).
 B.) Acicular Ferrite Laths and Retained Austenite at the Lath Interfaces.

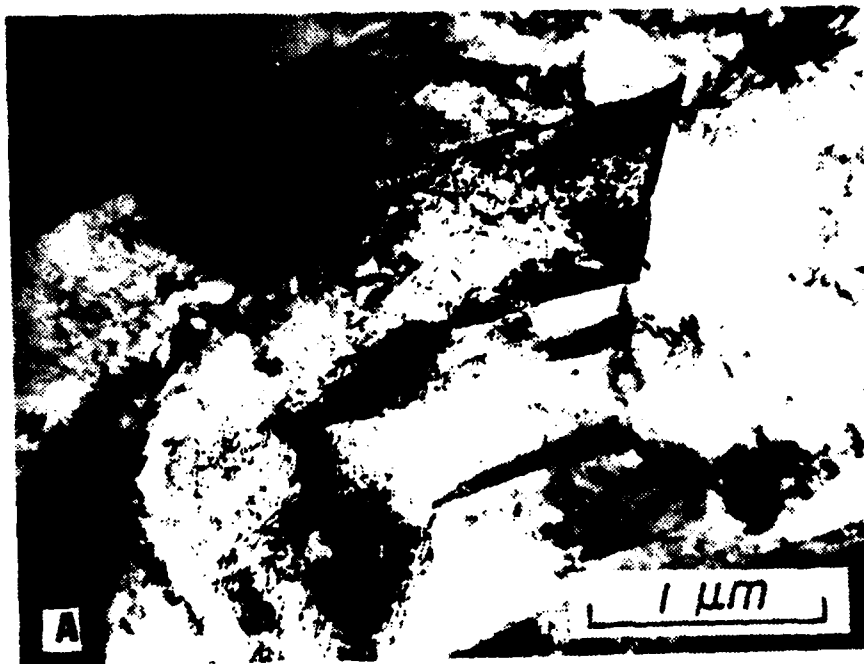
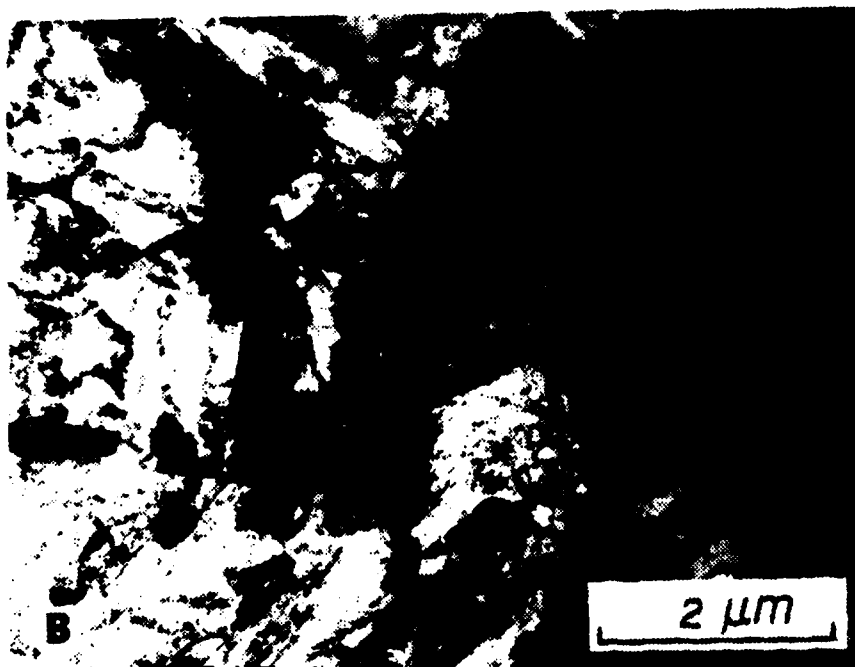
Figure 24. TEM Micrograph of Non-Preheated Sample HAZ at Fusion Line.
 A.) Islands of Carbide Aggregates and Retained Austenite at Lath Interface.
 B.) Islands of Carbide Aggregates.

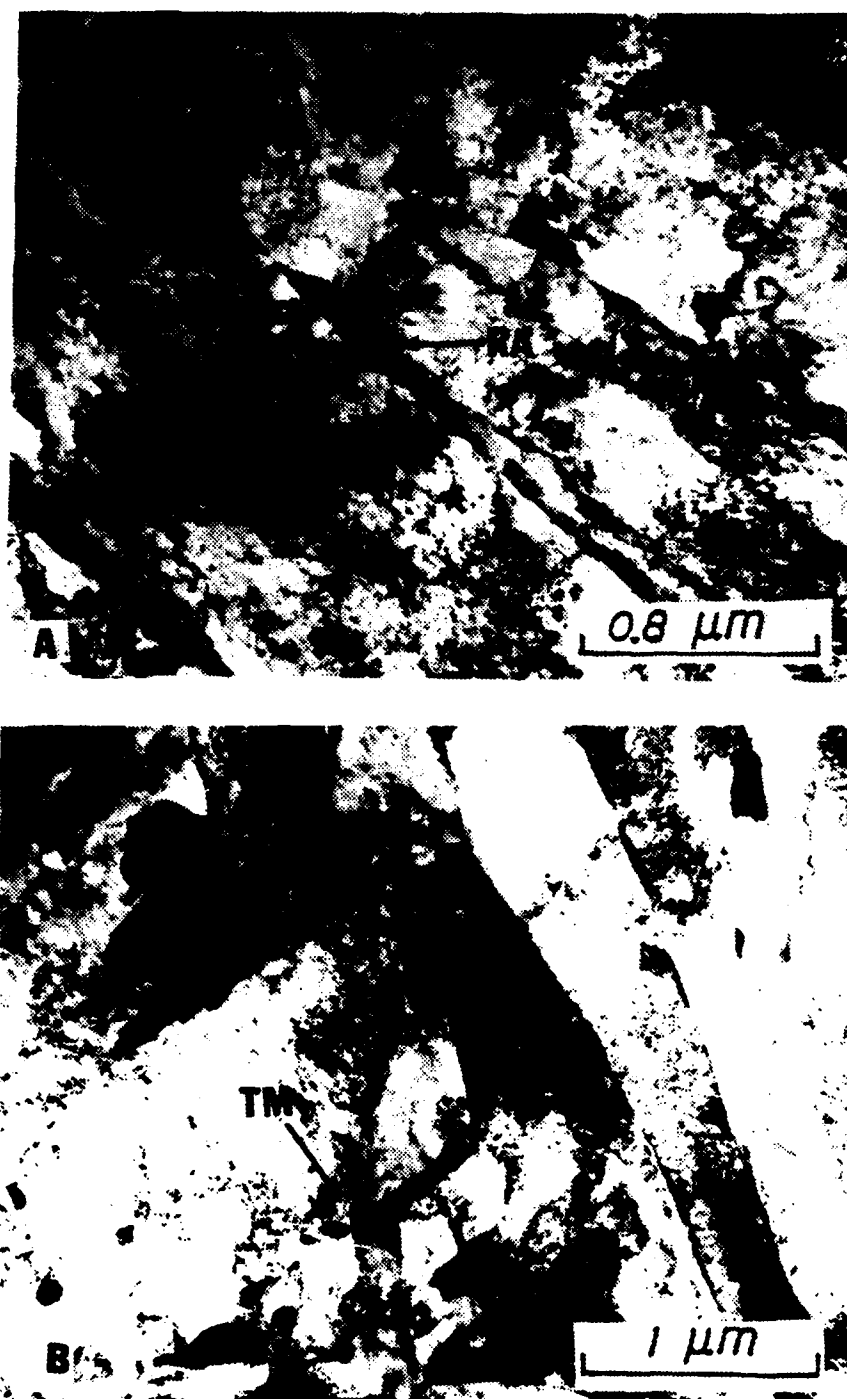
Figure 30. TEM Microstructure of Preheat Sample Weld Metal.
 A.) Retained Austenite at Lath Interfaces.
 B.) Islands of Tempered Martensite and Carbides
 on Grain Boundaries. Spheres are Inclusions.

SEM observations revealed a similar microstructure in the preheated and the non-preheated samples, Figure 29. TEM examination of the weld metal at the center of the weld revealed the same microstructures as those observed in the mixed region, however, the dislocation density is higher and more inclusions are present than in the mixed region, Figures 30 and 31.
